**STUDY SUMMARY – WHITE PAPER**

**January 12, 2023**

**Snouffer School Road High Injury Network Safety Study  
Recommendations Specific to Montgomery County DOT**

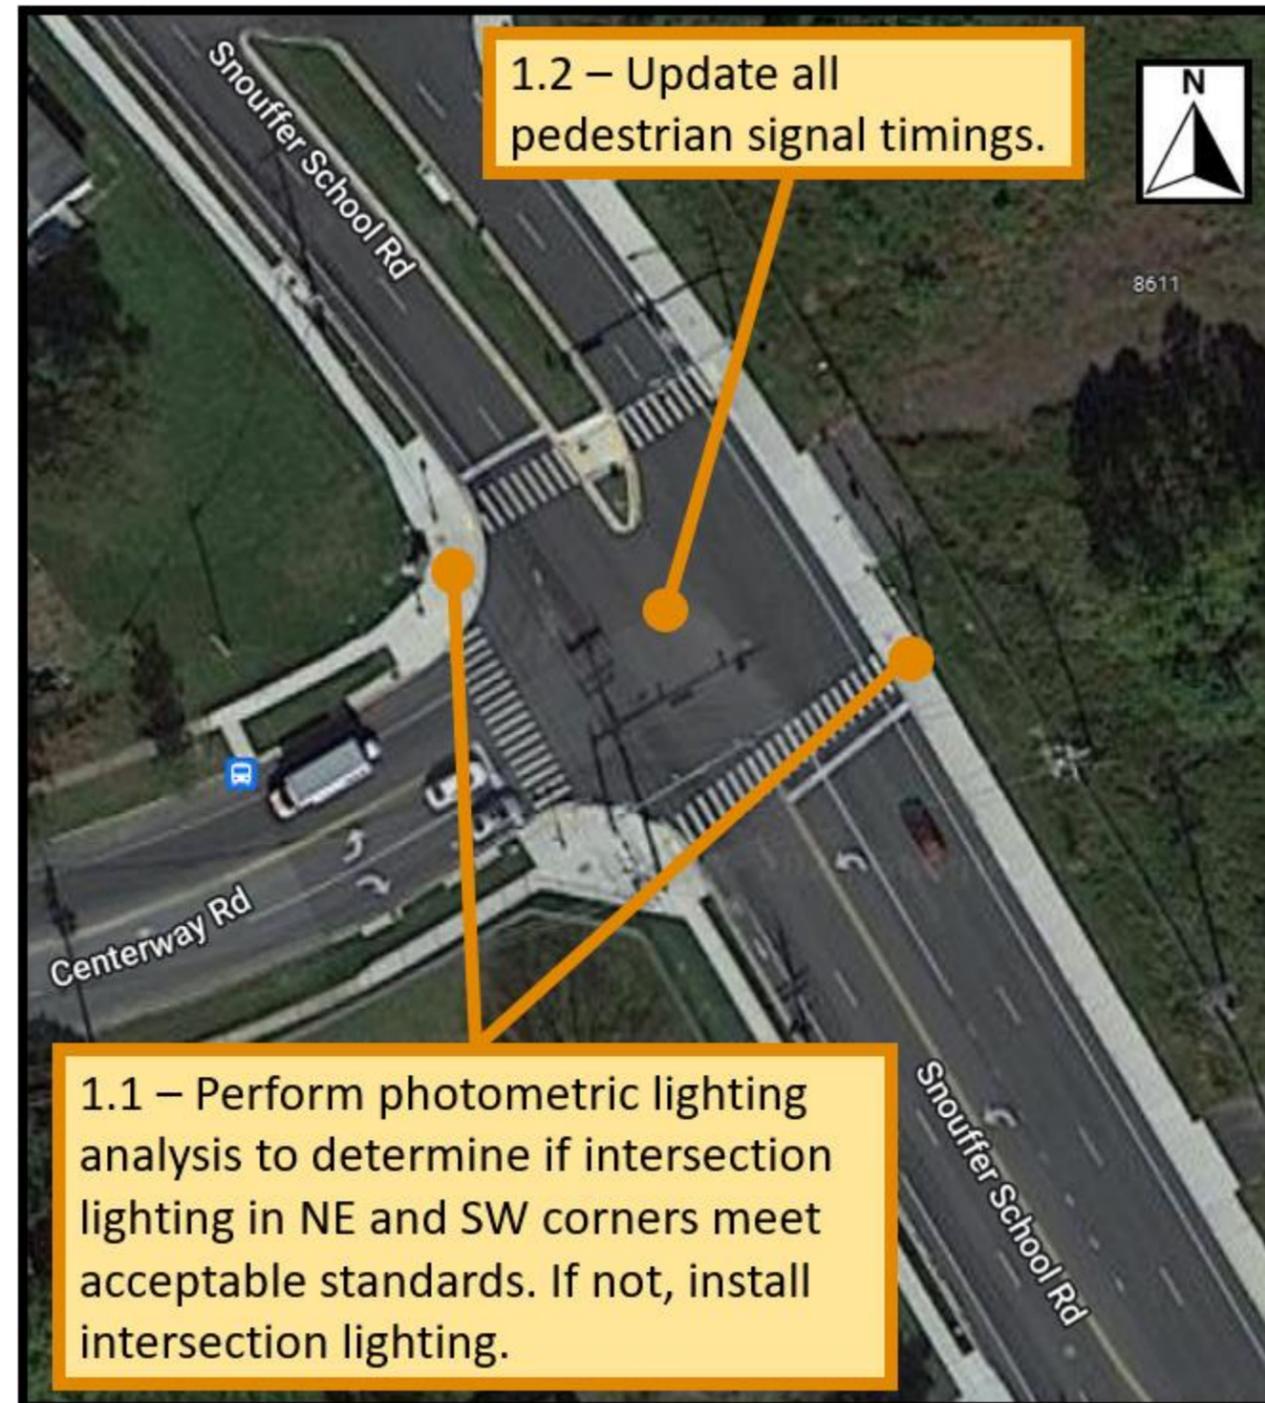
Figure 1: MCDOT – Specific Recommendations: Snouffer School Road at Centerway Road

Issue No.	Safety Issue/Observations	Recommendation	Timeframe
<b>Location 1: Snouffer School Road at Centerway Road – Signalized Intersection</b>			
1.1	Five crashes occurred under dark conditions when the lights were on at this intersection.	Perform a photometric lighting analysis to determine if intersection lighting in the NE and SW corners of the intersection meets acceptable standards. If not, install intersection lighting in the NE and SW corners of the intersection to meet acceptable standards.	6 – 12 months

1.2	Pedestrian Clearance Interval is insufficient for the east and west legs of the intersection (crossing Snouffer School Road).	Update pedestrian signal timings to ensure pedestrian clearance intervals are adequate.	0 – 6 months
<b>Location 2: Snouffer School Road between Centerway Road and Flower Hill Way/Earhart Court – Road Segment</b>

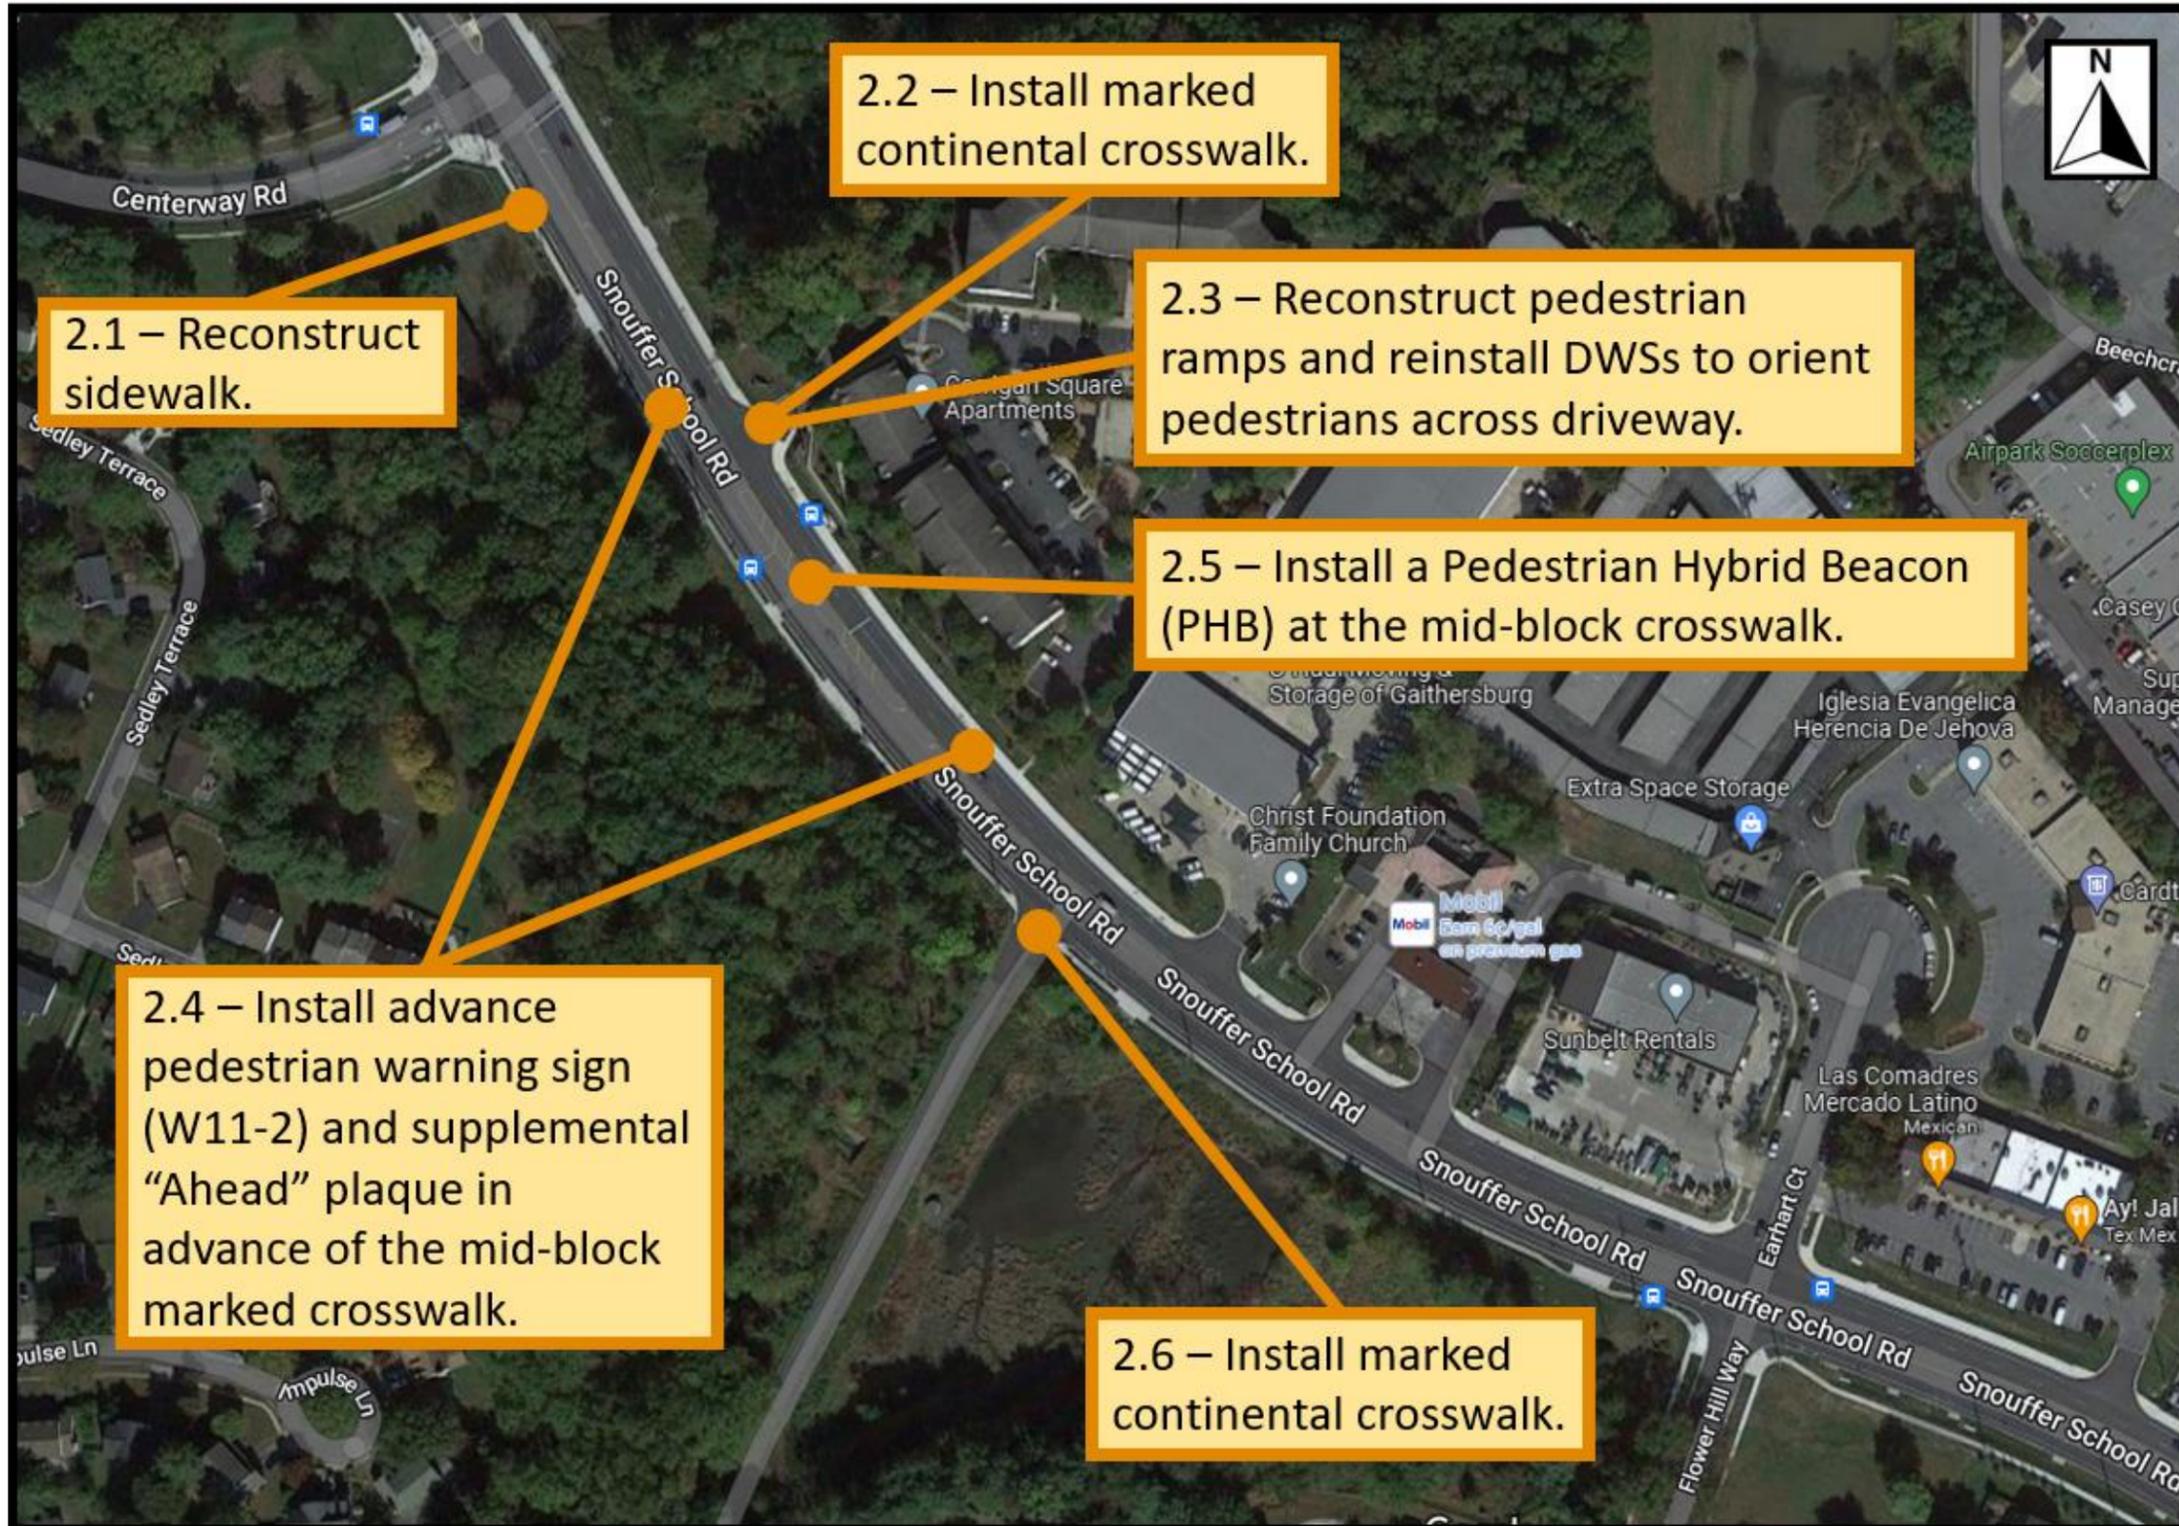
Figure 2: MCDOT – Specific Recommendations: Snouffer School Road between Centerway Road and Flower Hill Way/Earhart Court

2.1	Minor sidewalk spalling was noted along EB Snouffer School Road near Centerway Road.	Reconstruct sidewalk in the area of concern.	0 – 12 months
2.2	There is no marked crosswalk across the Corrigan Square Apartments access driveway.	Install marked continental crosswalk markings across the Corrigan Square Apartments access driveway.	0 – 6 months

2.3	The pedestrian ramps and DWSs at the Corrigan Square Apartments driveway are oriented toward the travel lanes of Snouffer School Road, rather than across the driveway.	Reconstruct the pedestrian ramps and reinstall DWSs at the Corrigan Square Apartments driveway to orient pedestrians across the driveway, rather than toward Snouffer School Road travel lanes.	6 – 12 months

2.4	There is no advance pedestrian warning sign along EB and WB Snouffer School Rd in advance of the mid-block marked crosswalk, east of Centerway Road.	Install an advance pedestrian warning sign (W11-2) and supplemental “Ahead” plaque along EB and WB Snouffer School Rd, in advance of the mid-block marked crosswalk, east of Centerway Road.	0 – 6 months

2.5	Pedestrians crossing at the midblock crosswalk east of Centerway Road are subject to vehicles that travel in excess of the speed limit and are subject to a multilane threat from vehicles.	Install a Pedestrian Hybrid Beacon (PHB) at the midblock crosswalk east of Centerway Road.	60+ months

2.6	There is no marked crosswalk across the Nike Missile Park entrance along EB Snouffer School Road.	Install marked continental crosswalk markings across the Nike Missile Park entrance.	0 – 6 months
<b>Location 3: Snouffer School Road at Flower Hill Road/Earhart Court – Unsignalized Intersection</b>

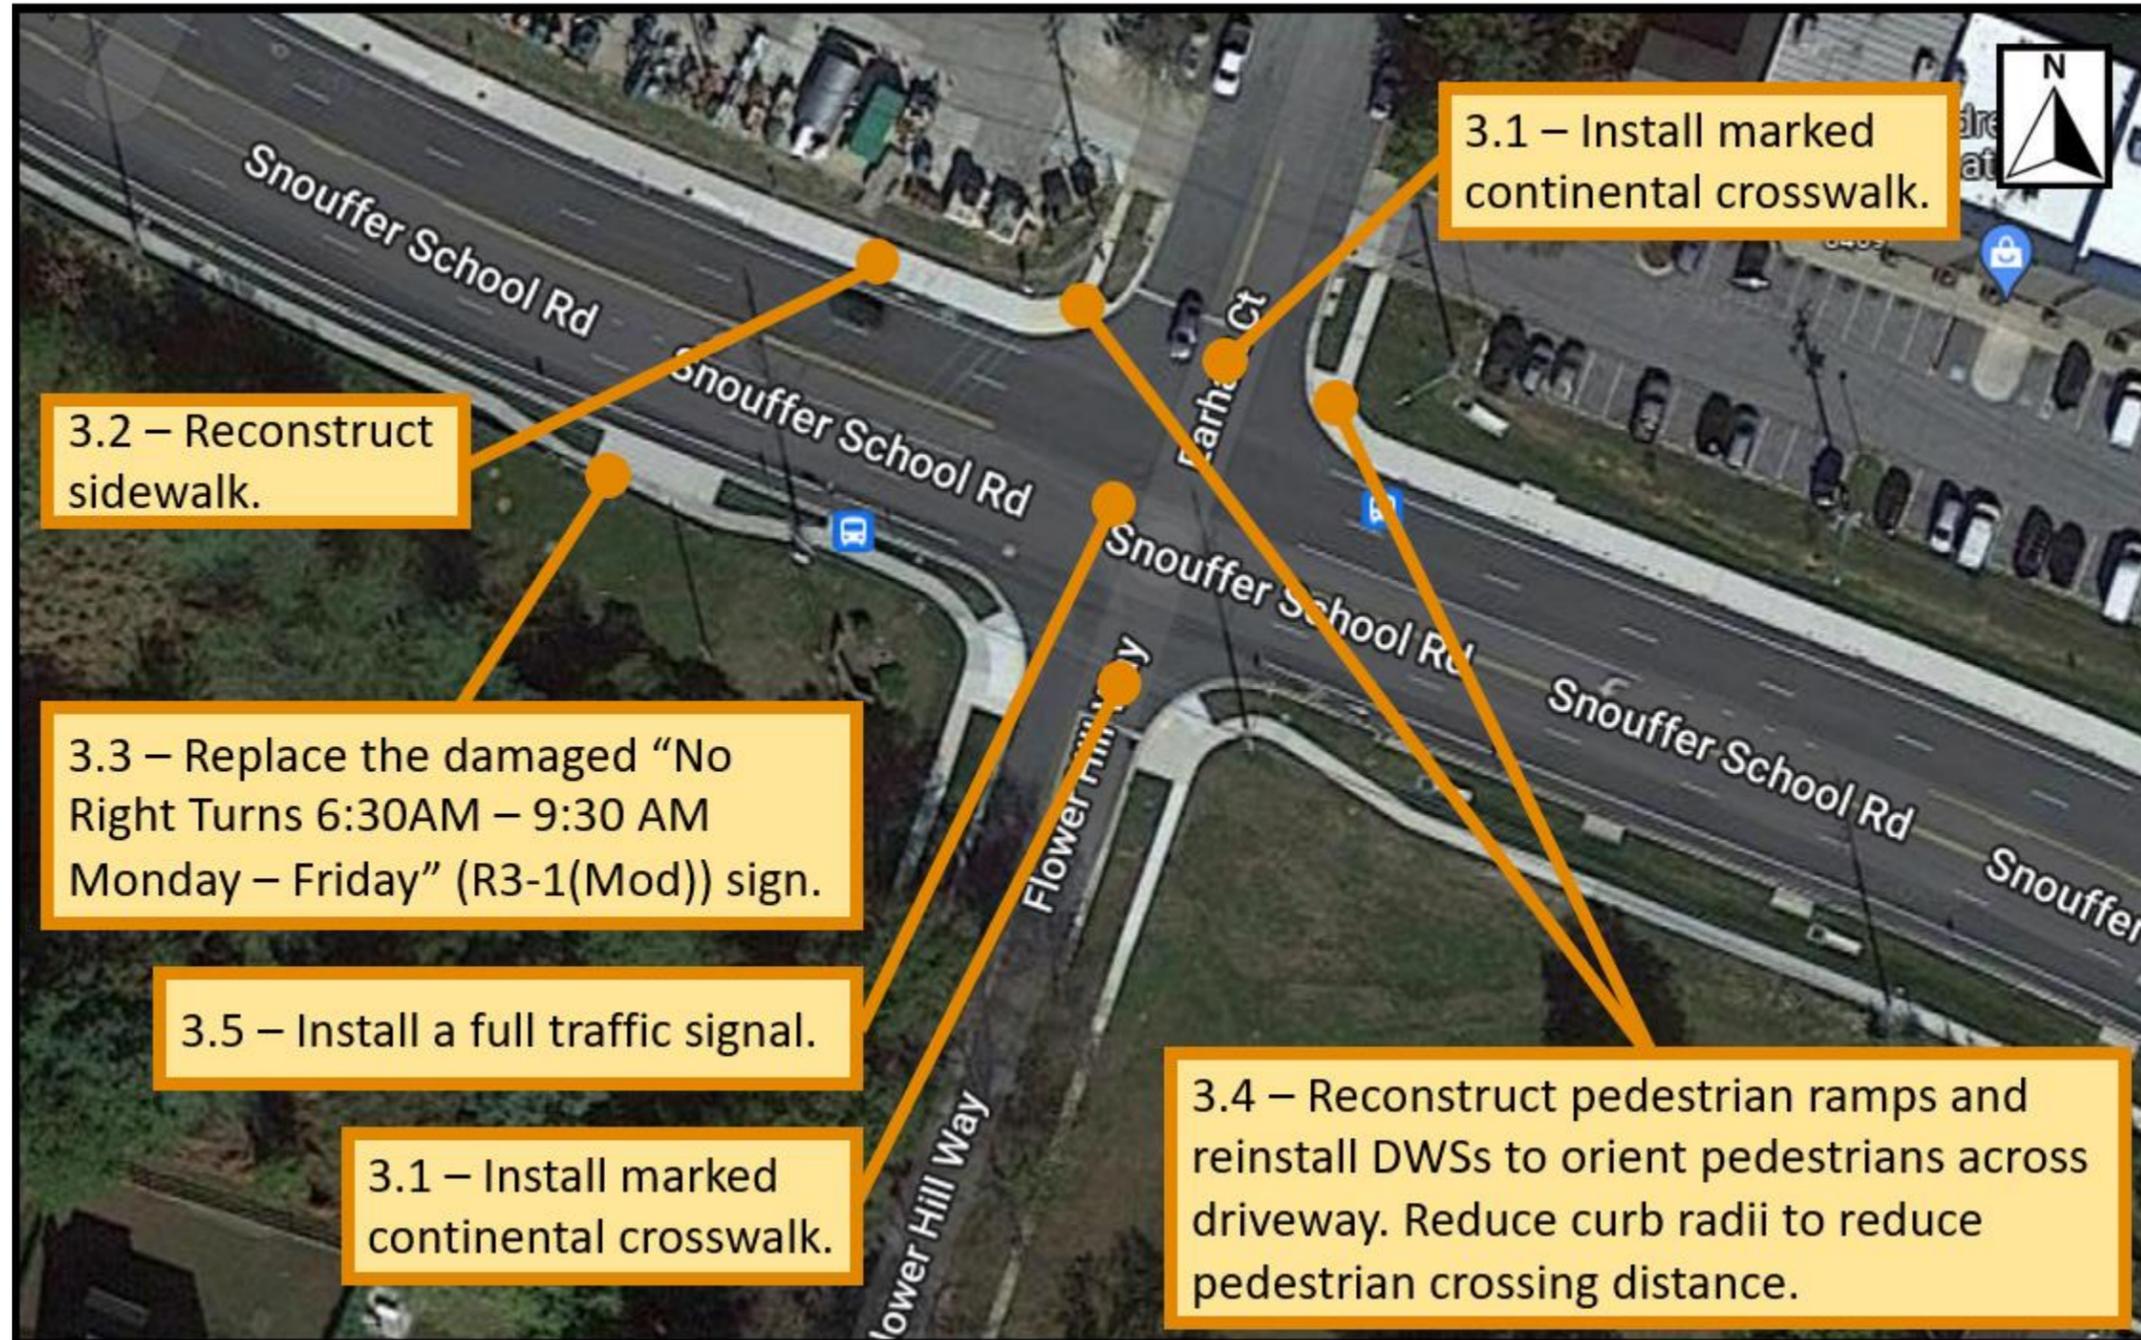
Figure 3: MCDOT – Specific Recommendations: Snouffer School Road at Flower Hill Road/Earhart Court

3.1	There are no marked crosswalks across the Flower Hill Road or Earhart Court intersection legs. Please see	Install marked continental crosswalks across the Flower Hill Road and Earhart Court intersection legs.	0 – 6 months

3.2	Sidewalk spalling was noted near Earhart Court.	Reconstruct sidewalk in the area of concern	0 – 12 months
3.3	The right turn restriction sign along EB Snouffer School, in advance of Flower Hill Way, is damaged.	Replace the damaged “No Right Turns 6:30AM – 9:30AM Monday – Friday” (R3-1(Mod)) sign along EB Snouffer School Road, in advance of Flower Hill Way.	0 – 6 months

3.4	The pedestrian ramps and DWSs in the NE and NW corners of the intersection (for crossing Earhart Court) are oriented toward the travel lanes of Snouffer School Road, rather than across Earhart Court. Also, the curb radii are large, resulting in a longer crossing distance for pedestrians.	Reconstruct the pedestrian ramps and reinstall DWSs in the NE and NW corners of the intersection to orient pedestrians across Earhart Court, rather than toward Snouffer School Road travel lanes, as shown in the MCDOT’s Snouffer School Road Improvements Project plans. Reduce the curb radii in the NE and NW corners to reduce the pedestrian crossing distance.	6 – 12 months

3.5	The Snouffer School Road at Flower Hill Way/Earhart Court intersection is unsignalized, yet has moderate levels of traffic into and out of Flower Hill Way/Earhart Court, bus stop 26100 and 26084 along EB and WB Snouffer School Road, and there is no protected crossing of Snouffer School Road nearby.	Install a full traffic signal at Snouffer School Road at Flower Hill Road/Earhart Court.	60+ months

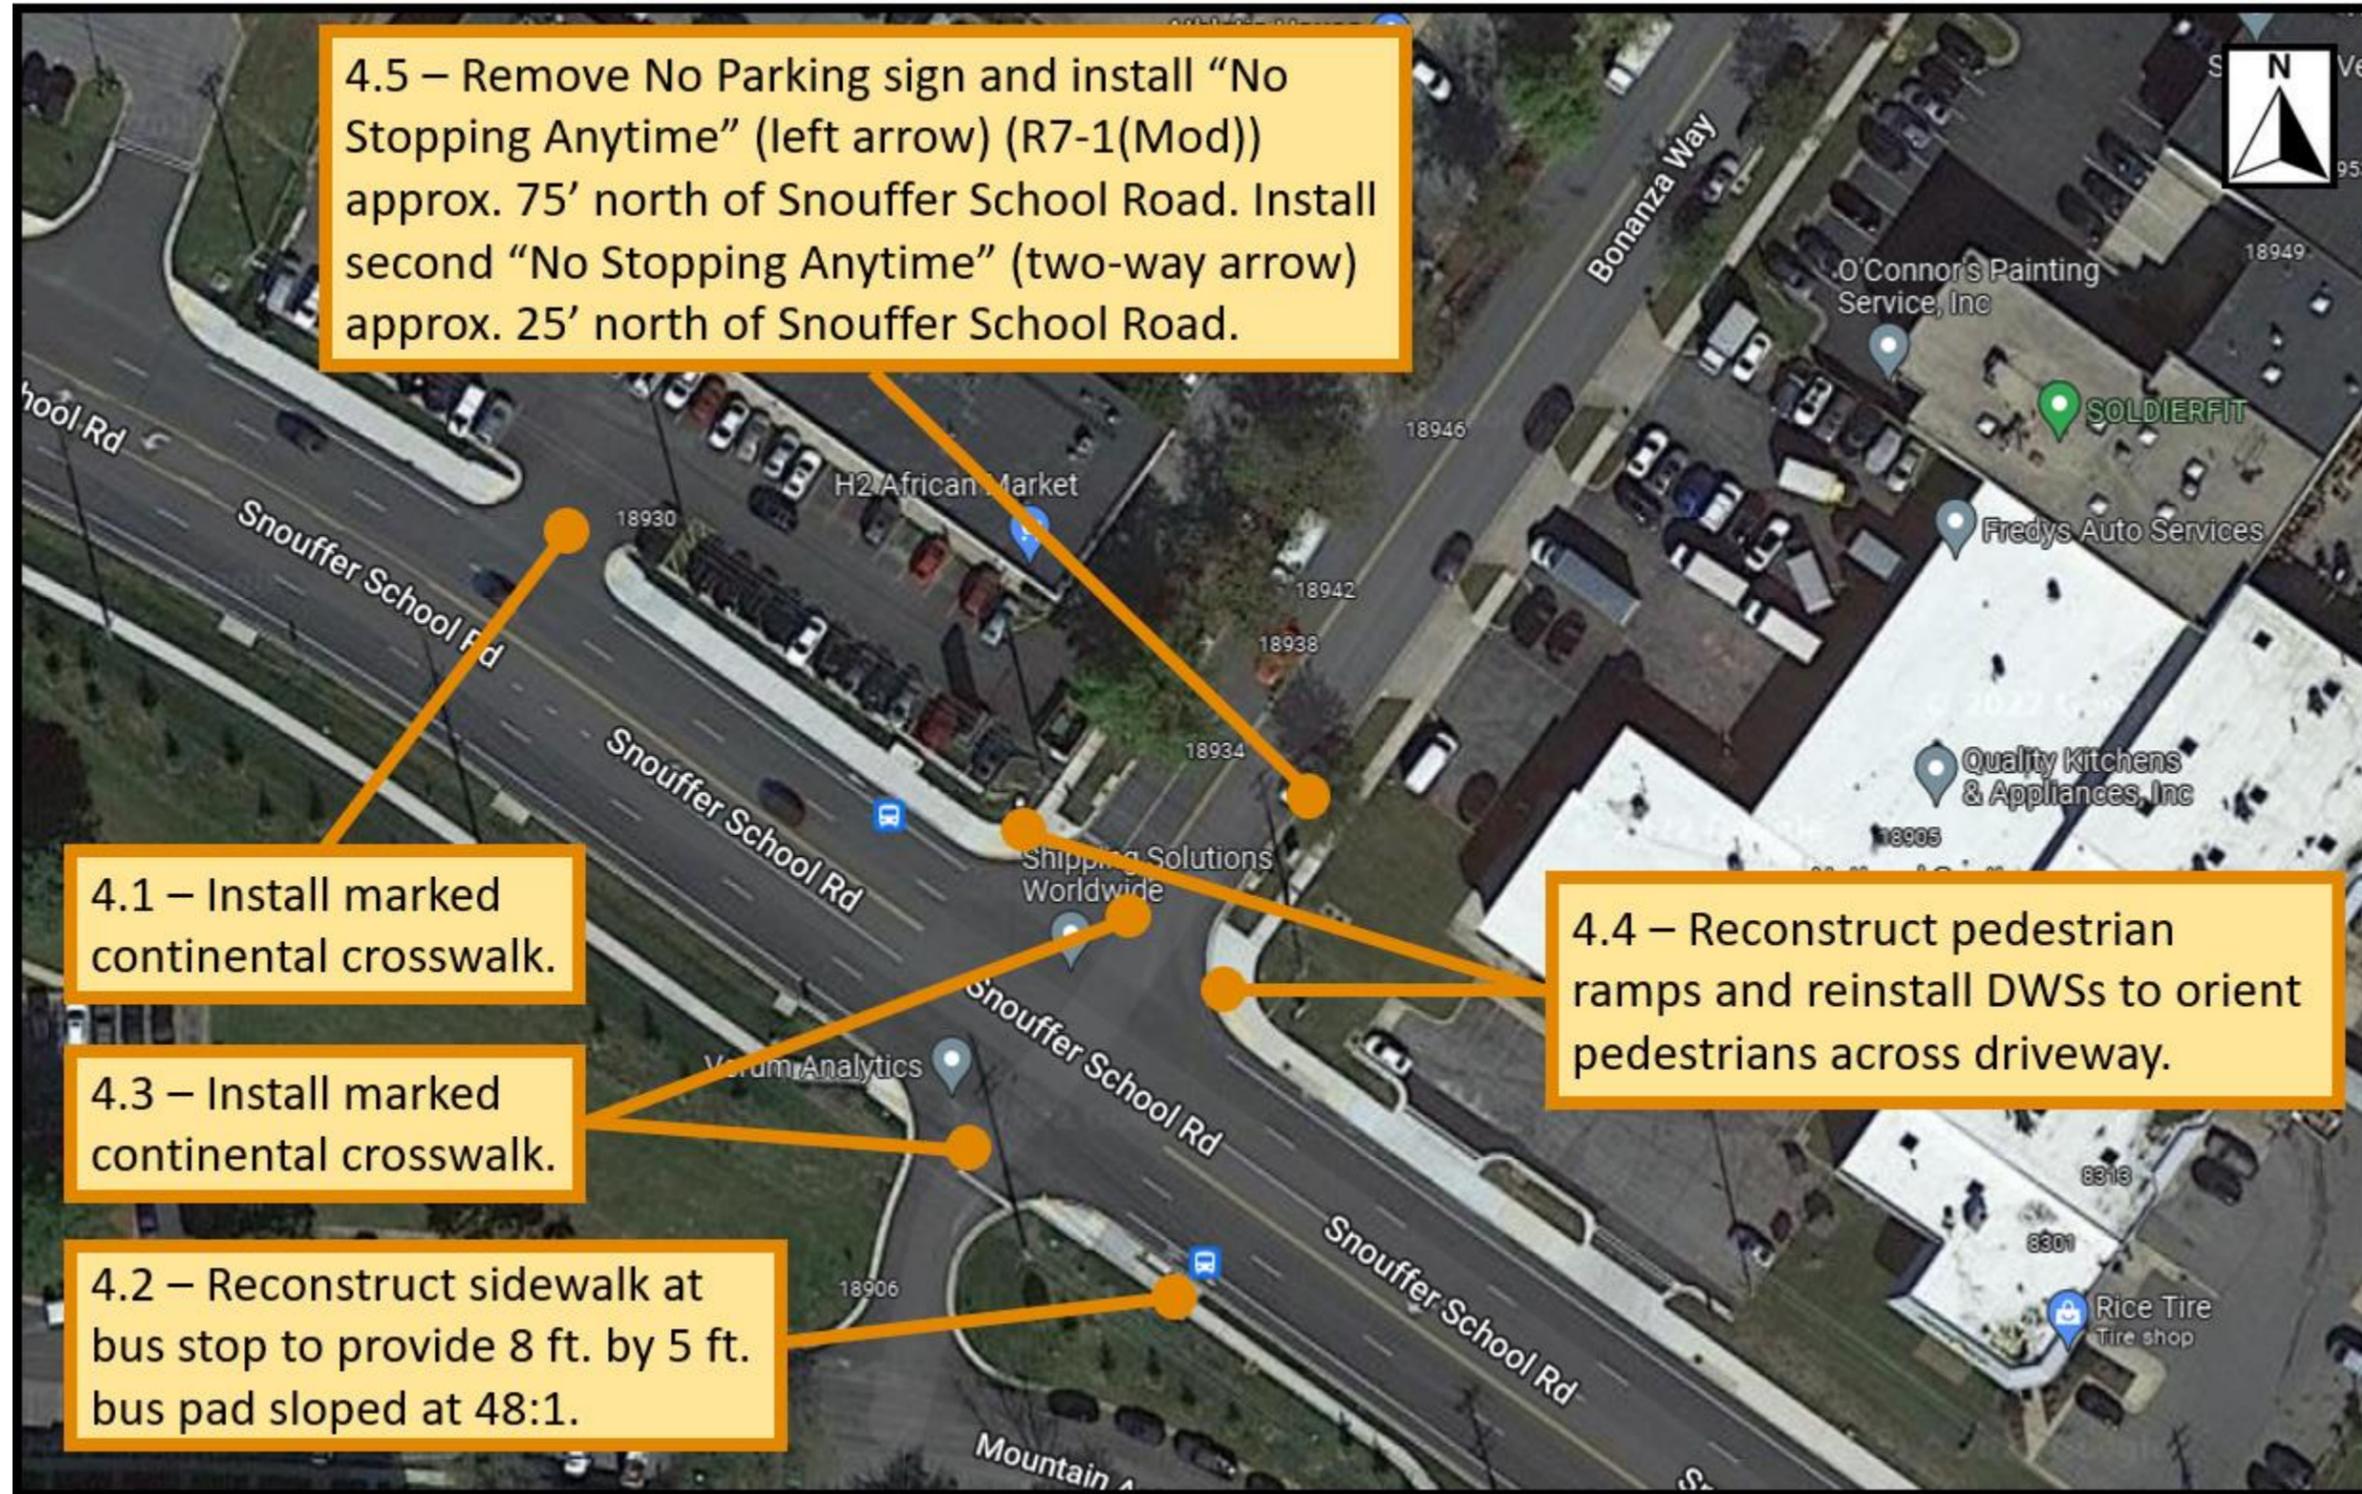
Figure 4: MCDOT – Specific Recommendations: Snouffer School Road at Bonanza Way

Issue No.	Safety Issue/Observations	Recommendation	Timeframe
Location 4: Snouffer School Road at Bonanza Way – Future Signalized Intersection			
4.1	There is no marked crosswalk across the Airpark Place Shopping Center Driveway along WB Snouffer School Road.	Install a marked continental crosswalk across the Airpark Place Shopping Center Driveway along WB Snouffer School Road.	0 – 6 months

4.2	The existing sidewalk at bus stop 26102 along EB Snouffer School Road, just east of Bonanza Way, appears to be higher in elevation than the top of the curb.	Reconstruct the sidewalk along EB Snouffer School Road at bus stop 26102 to provide an eight (8) ft. by five (5) ft. bus pad evenly sloped at 48:1.	0 – 6 months

4.3	There are no marked crosswalks across the north and south legs of the intersection (crossing Bonanza Way).	Install marked continental crosswalks on the north and south legs of Bonanza Way (crossing Bonanza Way).	0 – 6 months

4.4	The pedestrian ramps and DWSs in the NE and NW corners of the intersection (for crossing Bonanza Way) are oriented toward the travel lanes of Snouffer School Road, rather than across Bonanza Way.	Reconstruct the pedestrian ramps and reinstall DWSs in the NE and NW corners of the intersection to orient pedestrians across Bonanza Way, rather than toward Snouffer School Road travel lanes as shown in MCDOT’s Snouffer School Road Improvements Project plans.	6 – 12 months

4.5	Vehicles were observed parking along SB Bonanza Way within the right turn lane, and in areas that are signed as No Parking.	Remove the No Parking sign along SB Bonanza Way, closest to Snouffer School Road. Install a “No Stopping Anytime” (with left arrow sign) [R7-1(Mod)] along SB Bonanza Way, approximately 75 feet north of the stop bar on the approach to Snouffer School Road. Install a second “No Stopping Anytime” sign (with two-way arrow) along SB Bonanza Way, approximately 25 feet north of the stop bar on the approach to Snouffer School Road.	0 – 6 months
Location 5: Snouffer School Road between Bonanza Way and Carriage Walk Drive

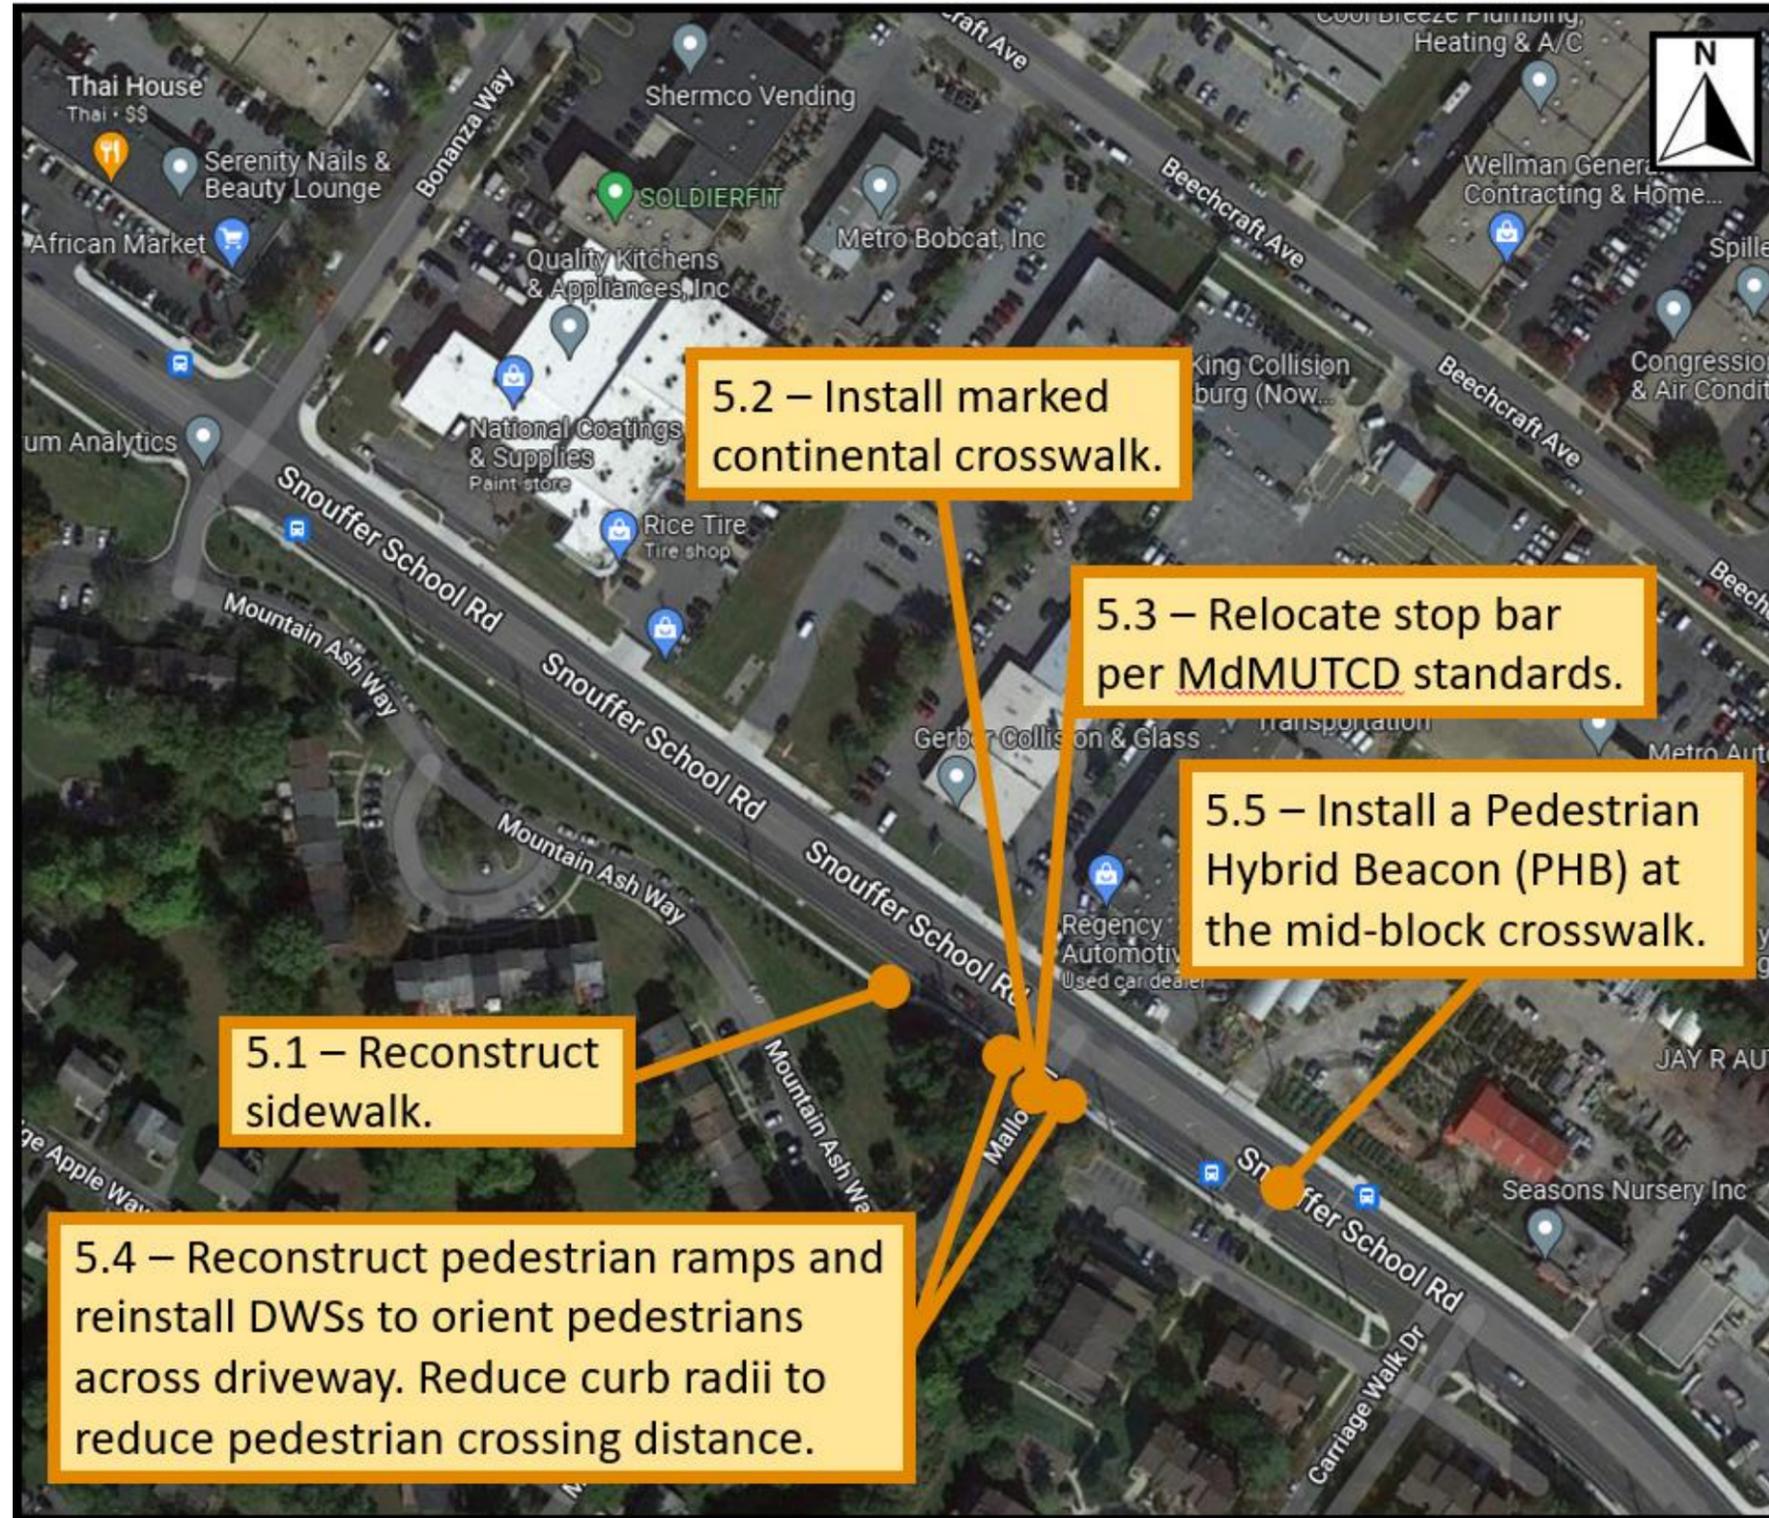
Figure 5: MCDOT – Specific Recommendations: Snouffer School Road between Bonanza Way and Carriage Walk Drive

5.1	Sidewalk spalling was noted along Snouffer School Road, west of Mallory Place.	Reconstruct sidewalk in the area of concern.	0 – 12 months
5.2	There is no marked crosswalk across the Mallory Place intersection leg along EB Snouffer School Road.	Install a marked continental crosswalk across the Mallory Place intersection leg along EB Snouffer School Road.	0 – 6 months

5.3	The Stop bar is not adjacent to the stop sign at Mallory Place.	Relocate the stop bar per MdmUTCD standards.	0 – 6 months
5.4	In the SE and SW corners Mallory Place, the curb radii are large, resulting in a longer crossing distance for pedestrians.	Reconstruct the pedestrian ramps and reinstall DWSs in the SE and SW corners of the intersection to orient pedestrians across Mallory Place, rather than toward Snouffer School Road travel lanes. Reduce the curb radii in the SE and SW corners to reduce the pedestrian crossing distance.	6 – 12 months

5.5	Pedestrians crossing at the midblock crosswalk west of Carriage Walk Drive are subject to vehicles that travel in excess of the speed limit and are subject to a multilane threat from vehicles.	Install a Pedestrian Hybrid Beacon (PHB) at the midblock crosswalk west of Carriage Walk Drive.	60+ months
Location 6: Snouffer School Road at Carriage Walk Drive – Unsignalized Intersection

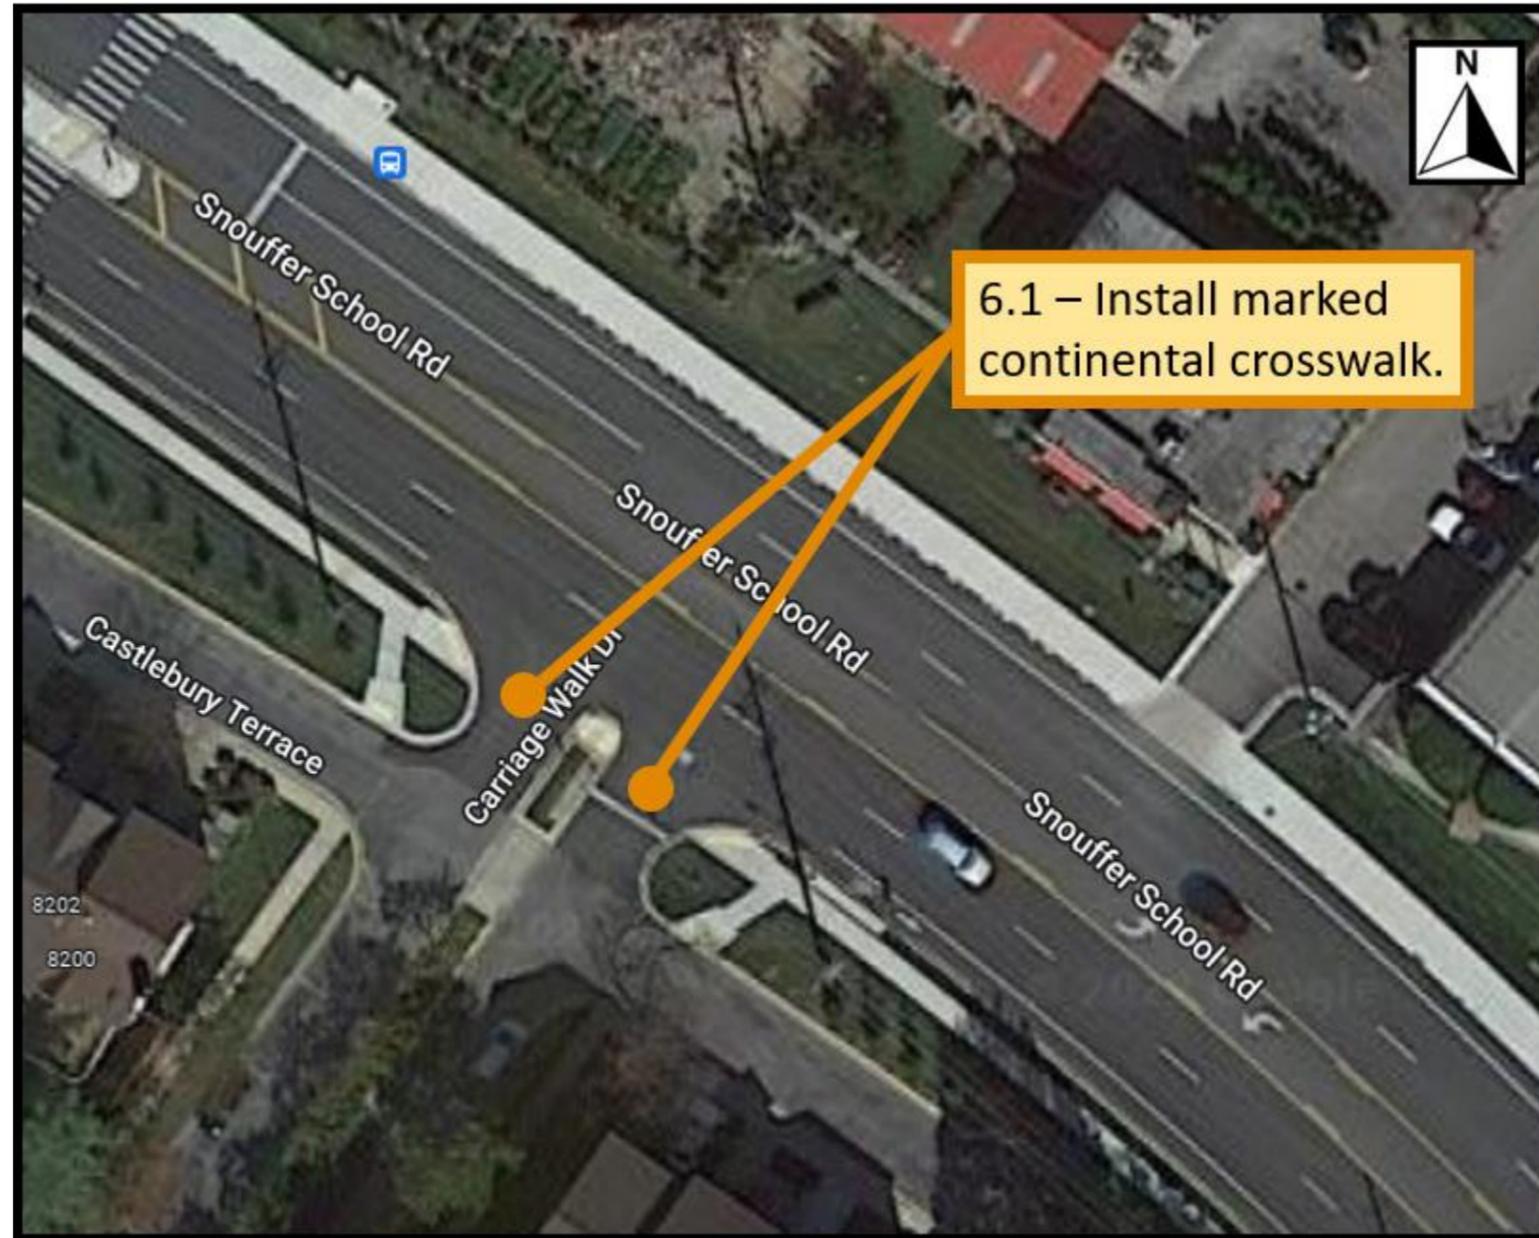
Figure 6: MCDOT – Specific Recommendations: Snouffer School Road at Carriage Walk Drive

6.1	There is no marked crosswalk across the Carriage Walk Drive intersection leg along EB Snouffer School Road.	Install a marked continental crosswalk across the Carriage Walk Drive intersection leg along EB Snouffer School Road.	0 – 6 months

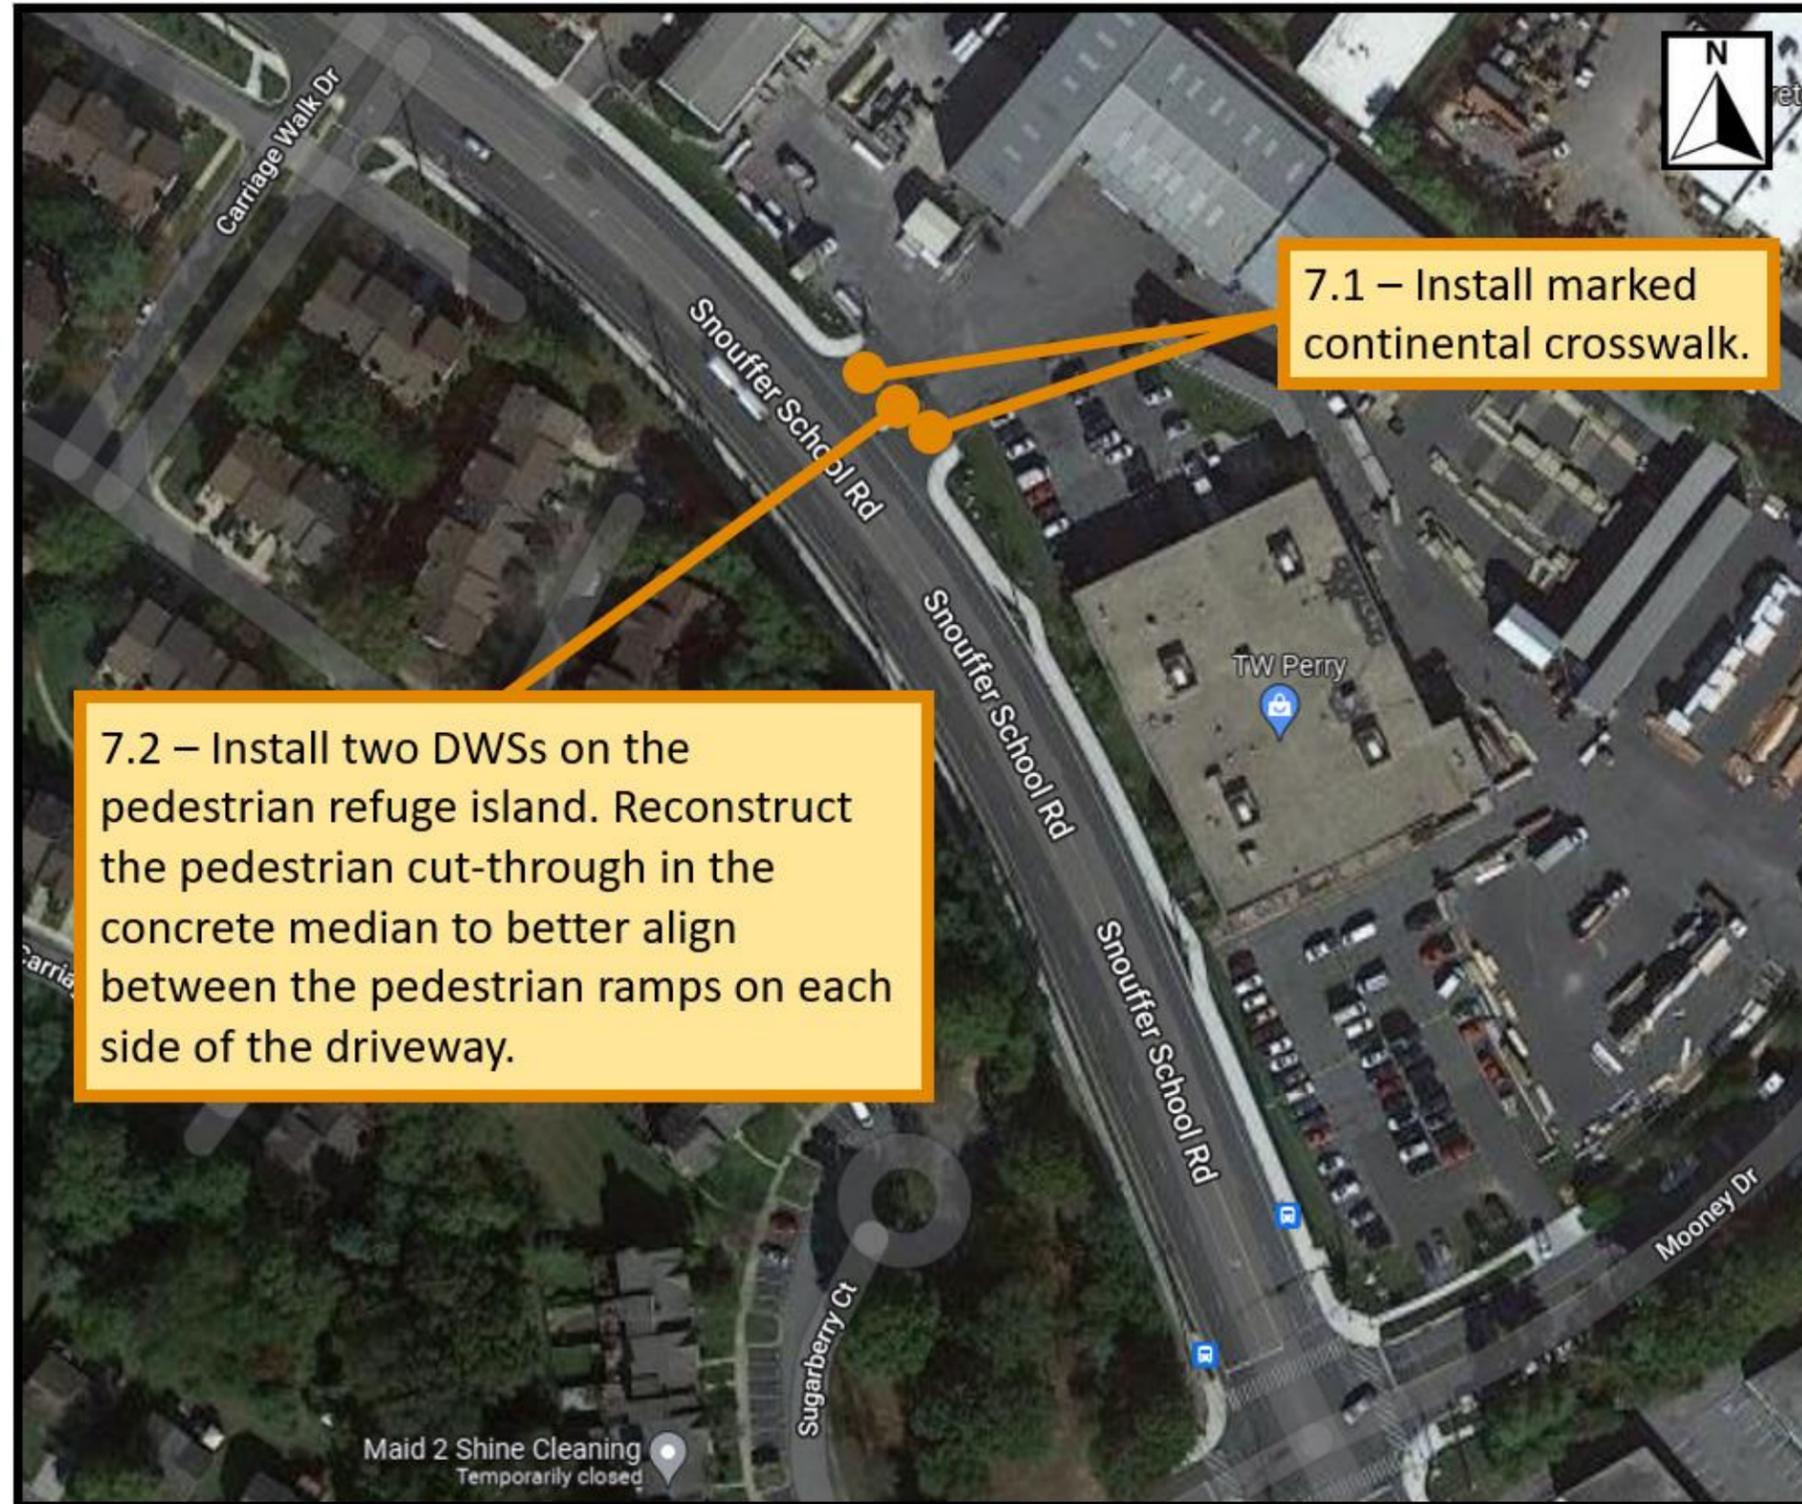
Figure 7: MCDOT – Specific Recommendations: Snouffer School Road between Carriage Walk Drive and Cherry Laurel Lane/Mooney Drive

7.1	There is no marked crosswalk across the TW Perry Driveway intersection leg along WB Snouffer School Road.	Install a marked continental crosswalk across the TW Perry Driveway intersection leg along WB Snouffer School Road.	0 – 6 months

7.2	There are no DWSs on the pedestrian refuge island on the TW Perry Driveway intersection leg, along WB Snouffer School Road.	Install two DWSs (minimum 2 feet apart) on the pedestrian refuge island on the TW Perry Driveway intersection leg, along WB Snouffer School Road. Additionally, reconstruct the pedestrian cut-through in the concrete median to better align between the pedestrian ramps on each side of the TW Perry Driveway.	0 – 12 months
Location 8: Snouffer School Road at Cherry Laurel Lane/Mooney Drive – Signalized Intersection
